## WOOD DESTROYING ORGANISM SUMMARY REPORT

## **WOOD DESTROYING ORGANISM REPORT**

1553 Barbara Drive, Eugene, Oregon 97405

3/15/2006 8:00 am to 12:00 pm

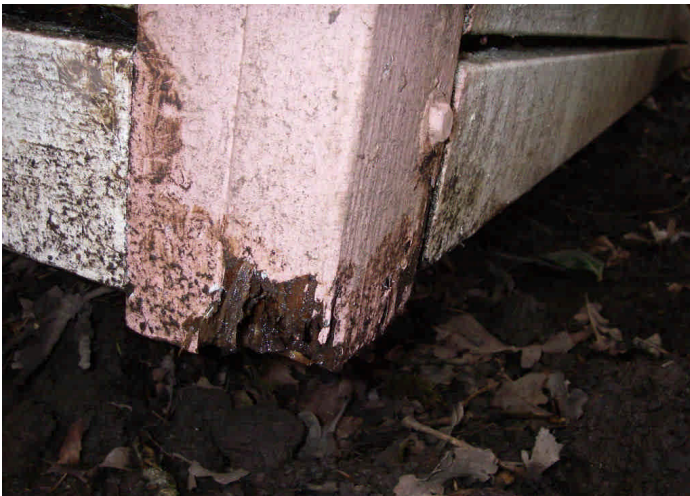
Wooden decks in Oregon are subject to moist conditions much of the year which promote wood decay. Most wood decks are replaced every 12 to 15 years and should not be expected to last indefinitely. There is moisture damage to the rear deck off the master bedroom. The visible damage to this deck included damage to a rail post, lower railing members, and the top deck boards. We recommend that all damaged materials be replaced by a licensed contractor in a professional manner.

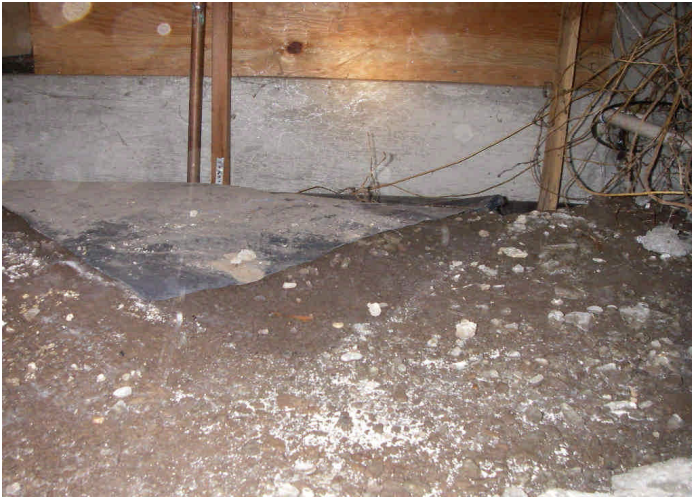
A section of the vapor barrier in the crawlspace has shifted or is missing. We recommend that the vapor barrier be repaired to cover all soil in the crawlspace.

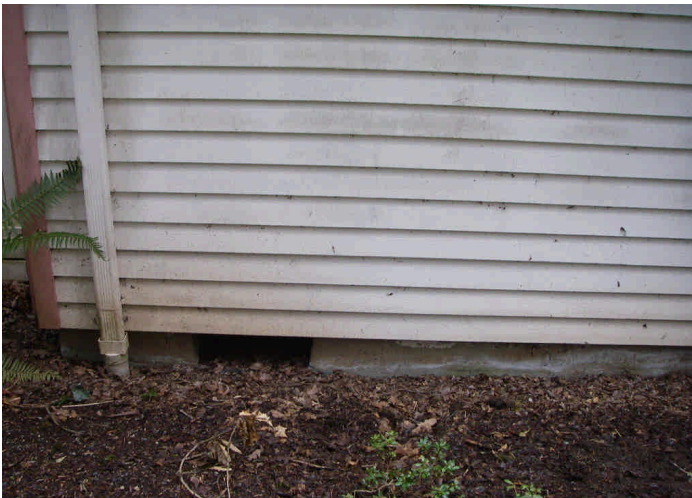
There is bark mulch in contact with a foundation vent. We recommend that a vent well made of rot resistant materials be installed at this vent to keep debris out of the crawlspace. See location in the diagram.

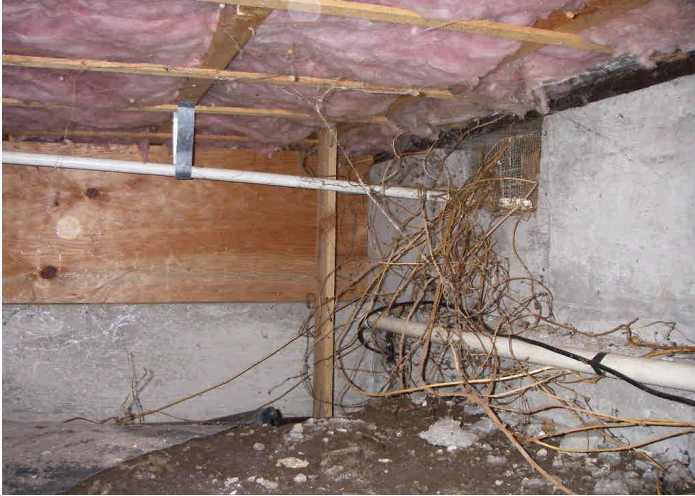
There is cellulose debris, wood scraps, and plant material in the crawlspace that should be removed as they can attract wood destroying organisms.

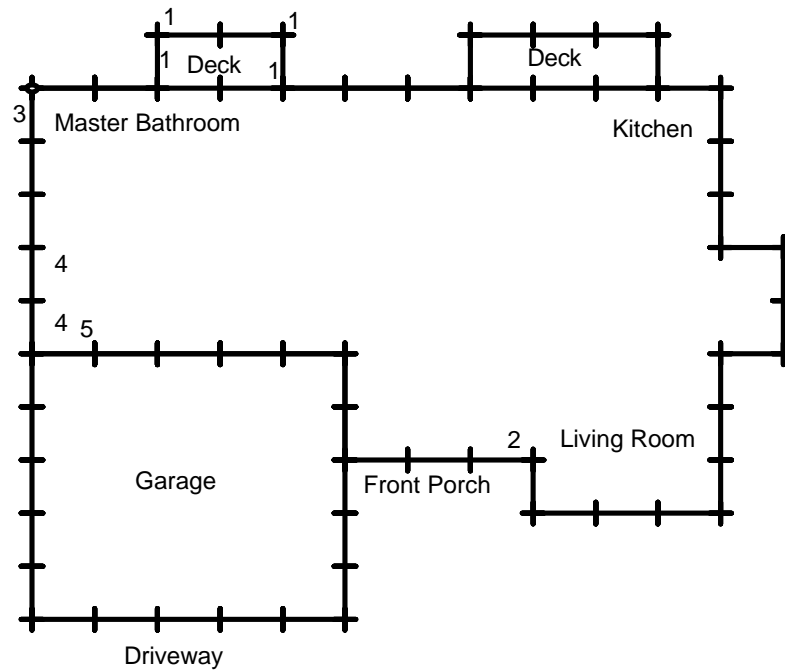
Wood Destroying Organism Report Diagram for 3003 Ashley Loop, Eugene, Oregon.

1. Moisture damage to deck off master bedroom, rail post, railing and deck boards.
2. Moisture damage to fascia board above front door.
3. Install vent well.
4. Cellulose debris.
5. Incomplete vapor barrier.
