BIRZER
Home Inspection

WHOLE HOUSE INSPECTION SUMMARY REPORT

Client: John and Mary Smith
Realtor: John Ingalls, University Real Estate
Inspection Address: 1553 Barbara Drive, Eugene, Oregon 97405
Inspection Date: 3/15/2006 Start: 8:00 am End: 12:00 pm
Inspected by: Randy Birzer

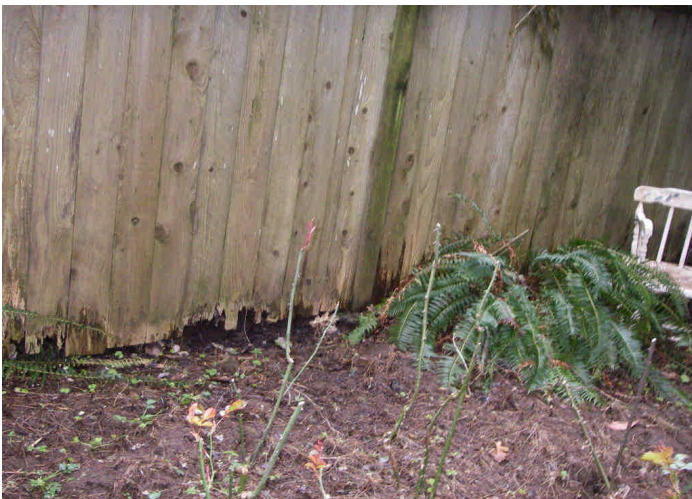
Sections of the fence are damaged and will need to be repaired at sometime in the future.

Both gates rubbed and were difficult to open. This is not an uncommon condition but you may wish to have it serviced.

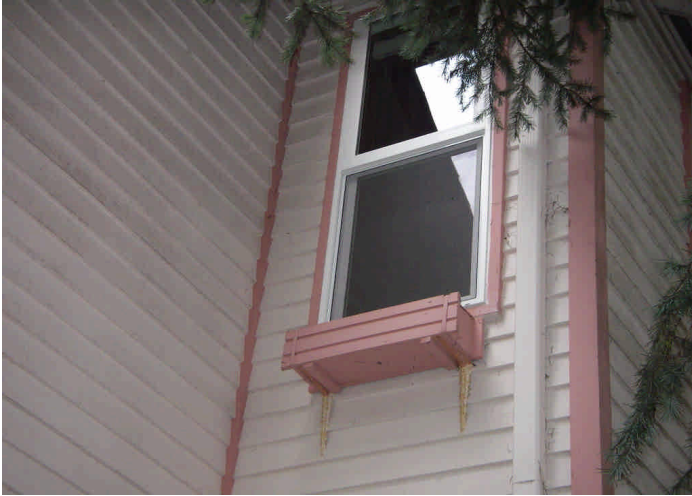
There are two planter boxes on the exterior of this home. It is common to find moisture damage to the siding behind such planter boxes. No damage was seen at this inspection but you may wish to remove these planter boxes as a preventative measure.

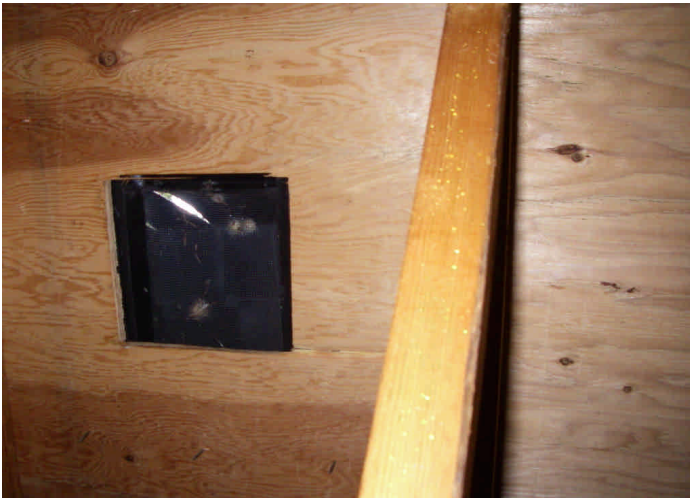
A roof vent above the garage is broken and should be replaced by a licensed contractor.

- A roof vent above the garage is broken and should be replaced by a licensed contractor.

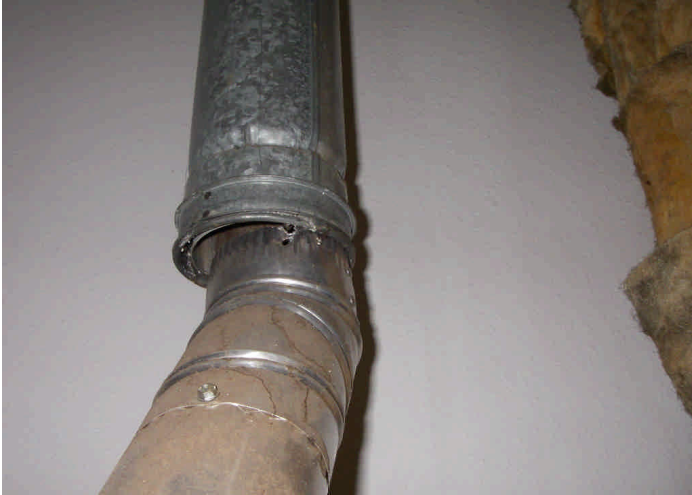
The vent pipe is not well seated and may need a different connector. The water heater vent should be repaired by a licensed contractor.

- The vent pipe is not well seated and may need a different connector. The water heater vent should be repaired by a licensed contractor.

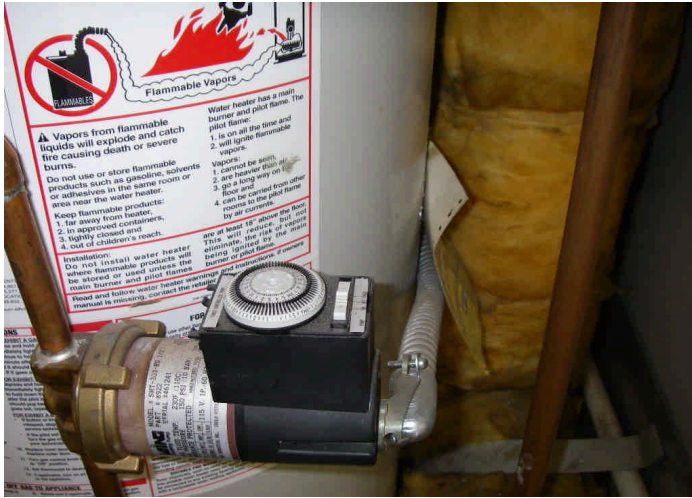
This residence has a hot water re-circulating system that includes a timer and appears functional at this time. There are pipes to the water re-circulating system in the garage and in the crawlspace that have no insulation. You may wish to install insulation on these pipes to increase energy efficiency and to protect against freezing.

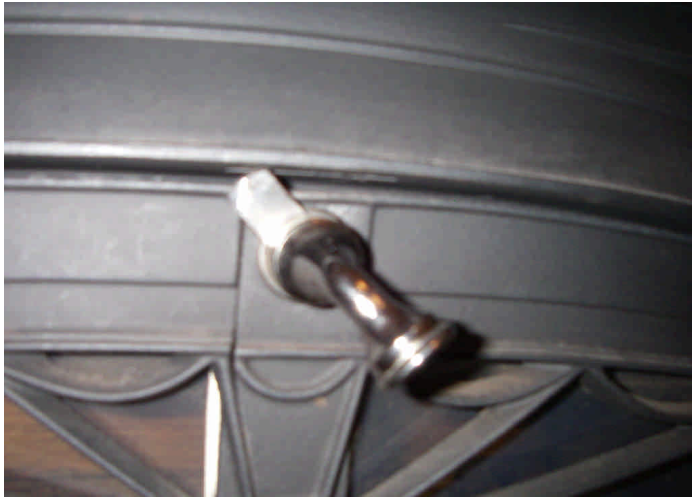
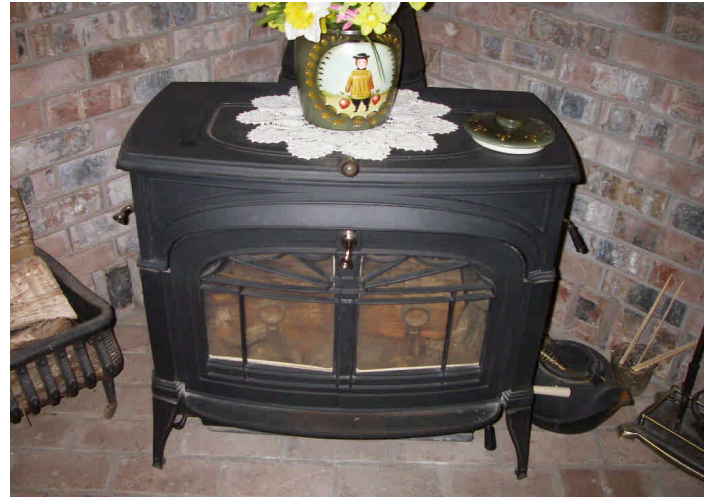
Wood Burning Stove

There is a wood burning stove in the family room. The locking mechanism for the doors will need to be adjusted to be functional. There are two controls on the sides of the stove which I was not able to identify and you should ask the sellers or a stove specialist to explain.

- There is a wood burning stove in the family room. The locking mechanism for the doors will need to be adjusted to be functional. There are two controls on the sides of the stove which I was not able to identify and you should ask the sellers or a stove specialist to explain.

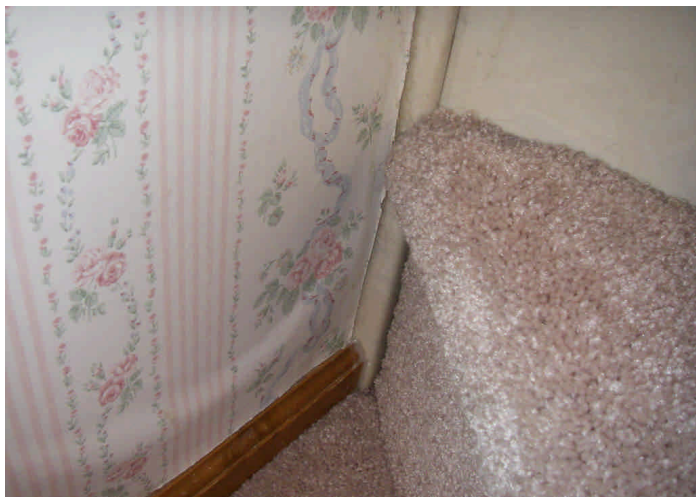
Some wall paper is not secure to the wall near the tub. The wall is solid and does not appear to be damaged. We recommend you monitor this location and take steps to keep water off the wall.

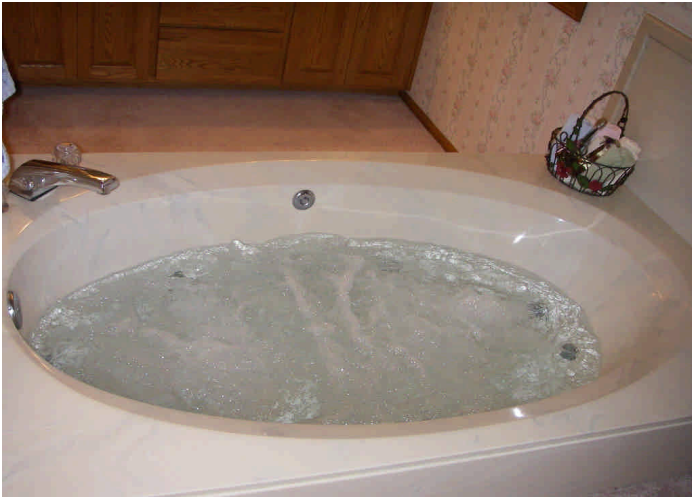
The hydro-spa is functional but should be flushed with a cleanser if not used frequently.

The hydro-spa does not appear to have ground fault protection, which is an essential safety feature that should be verified as being present or added.

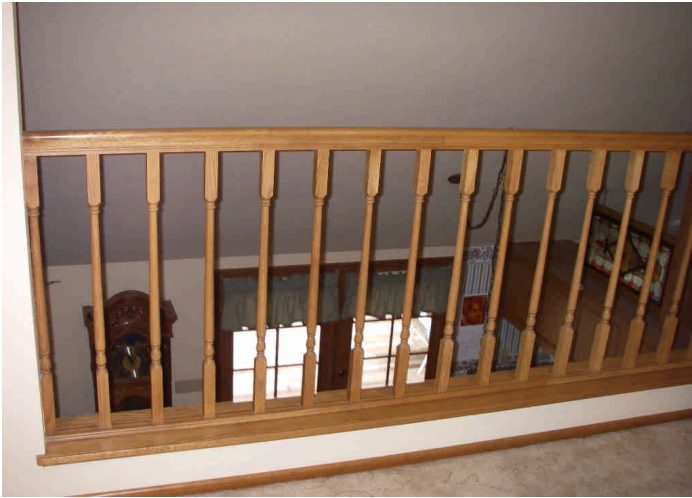
There is an open railing where the ballisters have gaps of up to 5 inches which could be a hazard to small children. If small children are to be present you should install some kind of barrier on this railing.
