## WOOD DESTROYING ORGANISM SUMMARY REPORT

## **WOOD DESTROYING ORGANISM REPORT**

1553 Barbara Drive, Eugene, Oregon 97405

3/15/2006 8:00 am to 12:00 pm

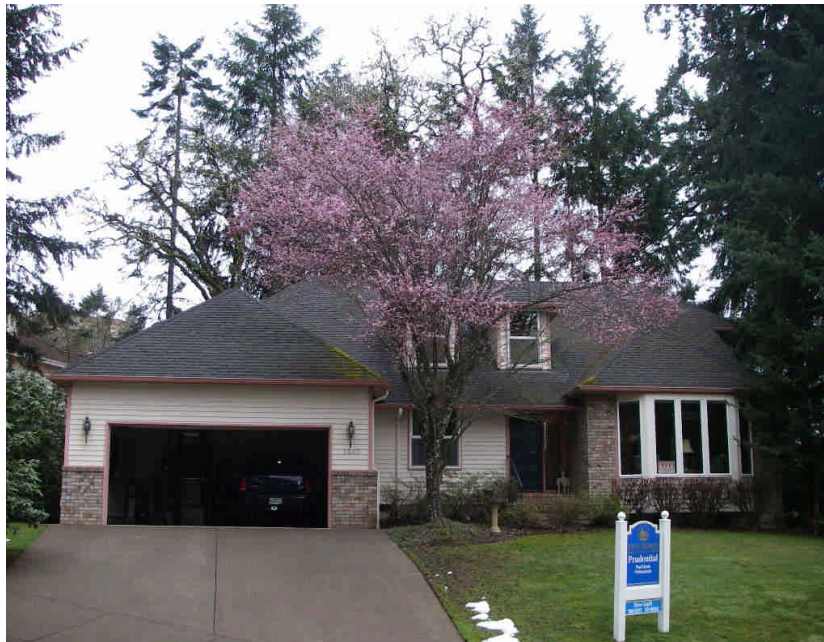
- Wooden decks in Oregon are subject to moist conditions much of the year which promote wood decay. Most wood decks are replaced every 12 to 15 years and should not be expected to last indefinitely. There is moisture damage to the rear deck off the master bedroom. The visible damage to this deck included damage to a rail post, lower railing members, and the top deck boards. We recommend that all damaged materials be replaced by a licensed contractor in a professional manner.
- There is section of fascia above the front door that is in contact with the roof and has moisture damage. We recommend that the damaged fascia be cut away. It appears that the damaged area can be removed and no additional material be installed.

- A section of the vapor barrier in the crawlspace has shifted or is missing. We recommend that the vapor barrier be repaired to cover all soil in the crawlspace.

- There is bark mulch in contact with a foundation vent. We recommend that a vent well made of rot resistant materials be installed at this vent to keep debris out of the crawlspace. See location in the diagram.
